Leading Edge erosion and pollution from wind turbine blades

5 th. Edition - English

Asbjørn Solberg, Bård-Einar Rimereit and
Jan Erik Weinbach
“THE TURBINE GROUP” JULY 2021

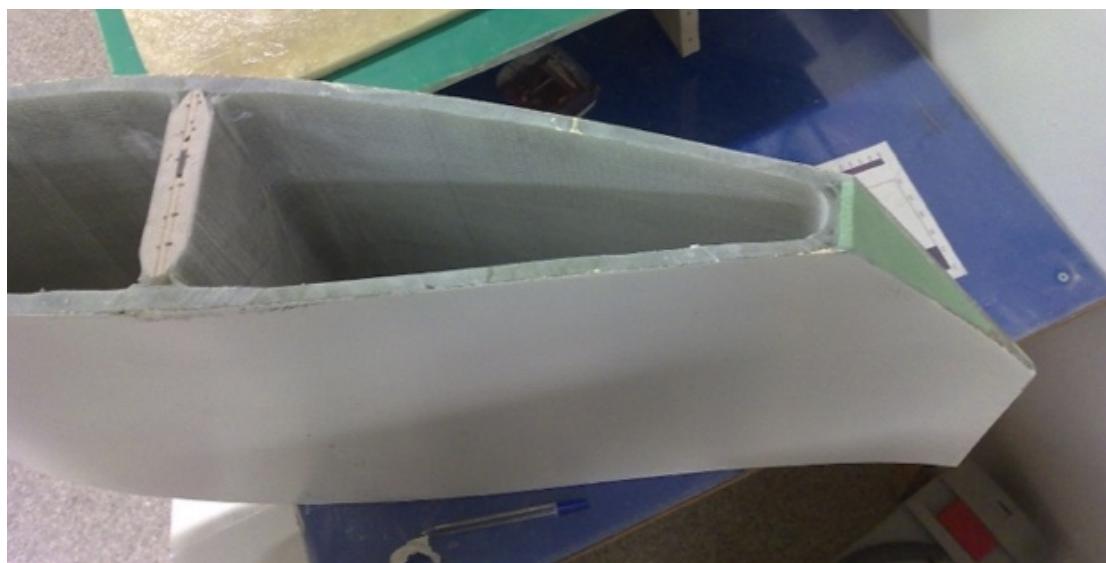
Figure 5 Photo: A small blade profile - to get an impression of proportions. Own photo, from testing
